Manhole Inspection Summary

Manhole # S37SS_026MH

Insp Date: **12/20/06 1:33 PM**

Location Address: **701 27TH ST**

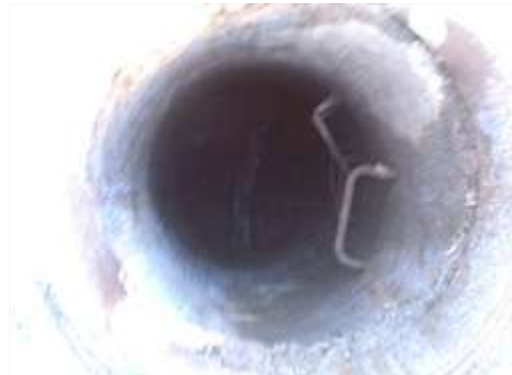
Top View

Bench debris.

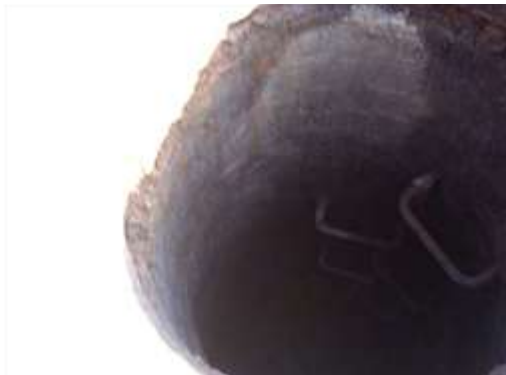
Defect

Condition: ☐ Sound ☐ Cracked ☐ Root Intrusion ☐ Loose Brick ☒ **Deteriorated**

Infiltration: ☐ None ☒ **Joint** ☐ Cracks ☐ Mortar ☐ Roots ☒ **Wall**

Adjustment deterioration and infiltration.

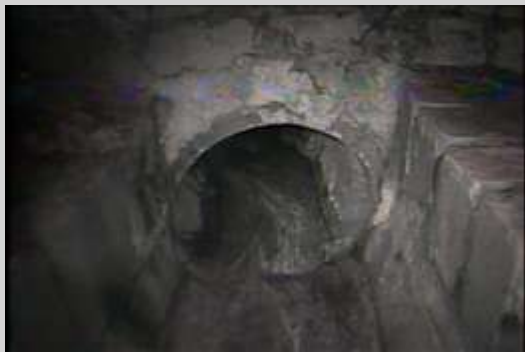
8 in. Circular Gravity Sewer Pipe Out @ 12 O'Clock

Deposits: ☐ None ☒ **Mud** ☐ Sludge ☒ **Debris** ☐ Grease

Silt Depth: **1** (in.) Deposits Extent: **Light**

Infiltration: **Evidence** Pipe Seal Cond: **Unknown**

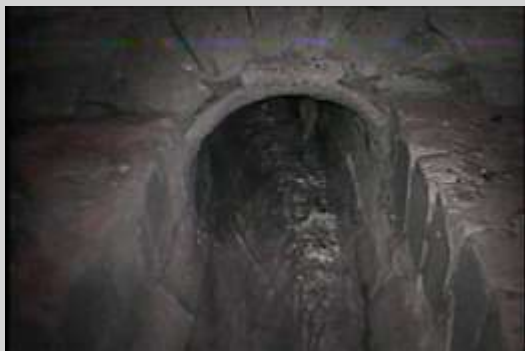
8 in. Circular Gravity Sewer Pipe In @ 7 O'Clock

Deposits: ☐ None ☐ Mud ☐ Sludge ☒ **Debris** ☐ Grease

Silt Depth: **0** (in.) Deposits Extent: **Light**
